NONDESTRUCTIVE INSPECTION OF SHELTER  
PANELS. PHASE 1: FUNCTIONAL MODEL

Irvin R. Kraska, et al

General American Transportation Corporation

May 1974

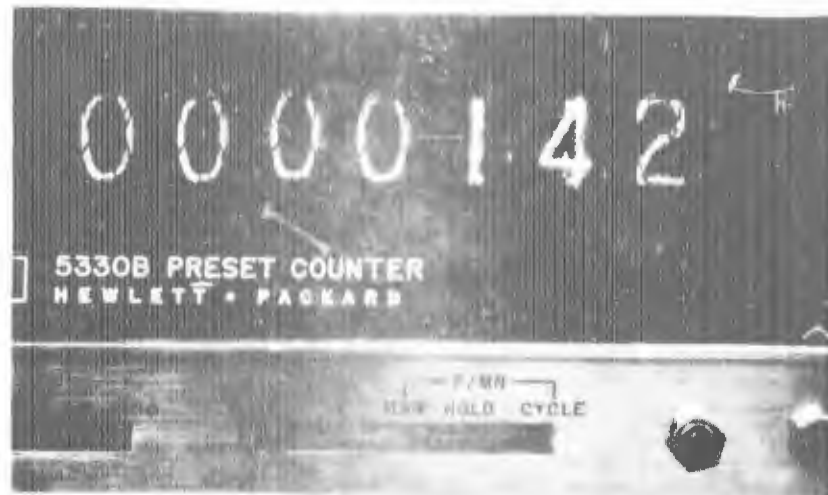
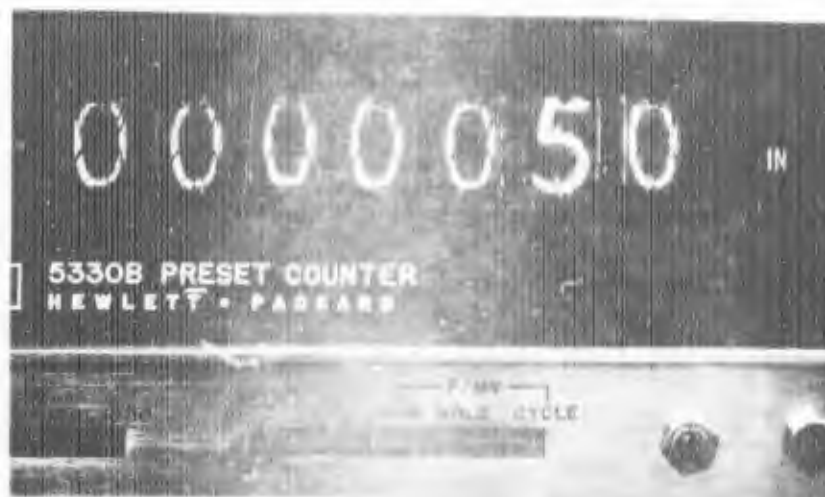
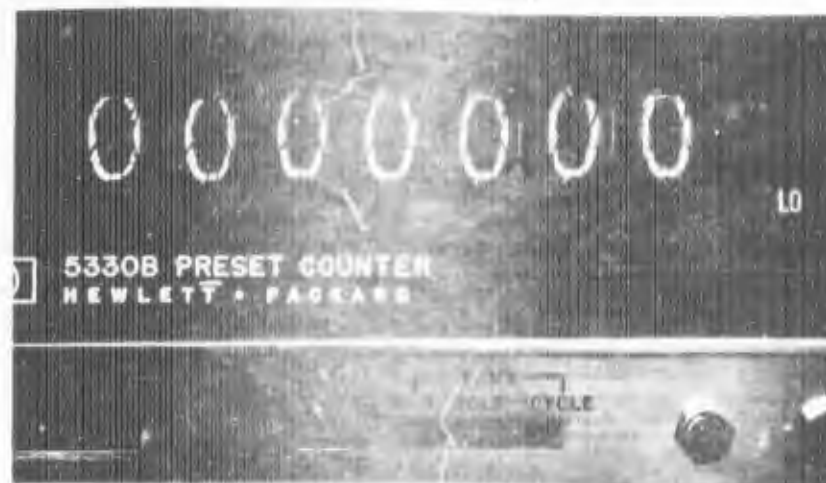
Figure 5 PHOTOGRAPHIC RECORD OF CHANGE IN FREQUENCY COUNTER READINGS DUE TO A DEBOND, BOND AND WATER

This arrangement was used to obtain the photographs shown in Figure 5. These photographs illustrate the change in counts due to bond, debond, and water conditions. The photograph in Figure 5a shows the Eddy Sonic output due to the presence a debond. The photograph is 5b shows the Eddy Sonics output from a bond. Figure 5c shows the signal due to water presence.

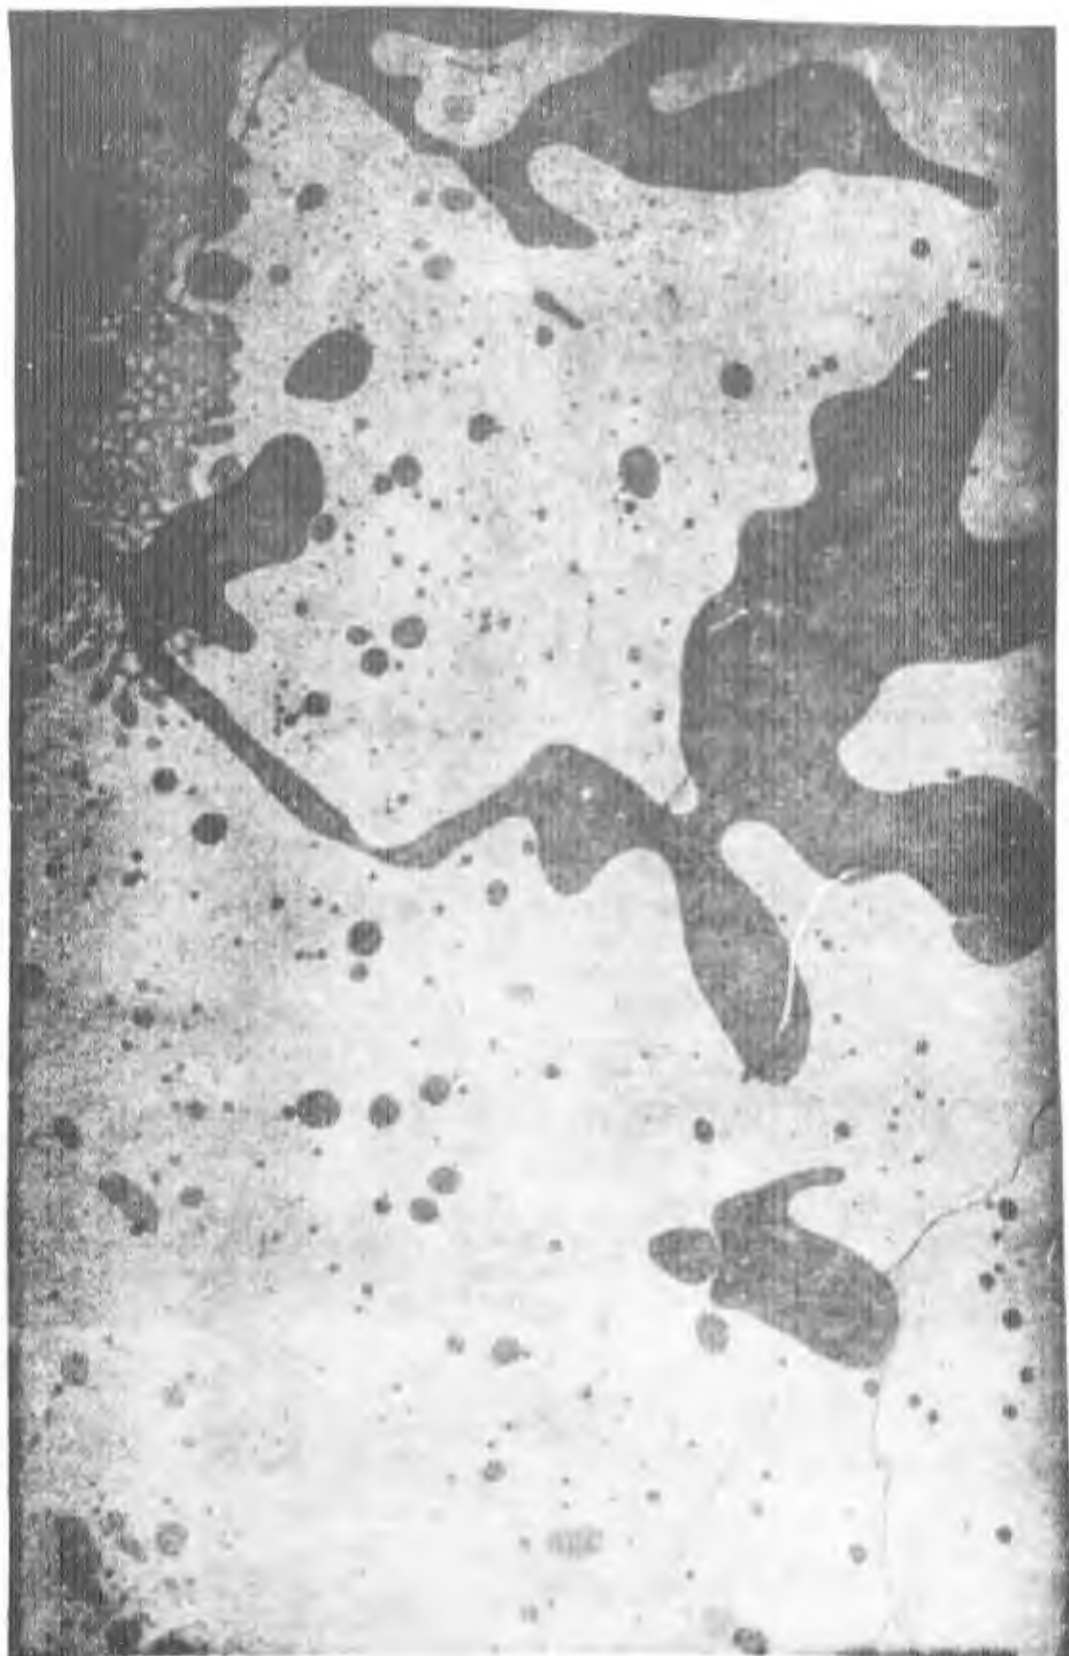
Figure B-1    TRANSMISSION X-RADIOGRAPH OF METAL-TO-FOAM  
SHELTER PANEL SAMPLE

Upon completion of the ultrasonic inspections, sections of panels representing the typical variations in ultrasonic results were removed from the shelter. Portions of the selected sections underwent additional testing using X-radiography. The radiographic results for a typical 5" x 9" section of aluminum-to-foam panel section are presented in Figure B-1. This sample had been selected for evaluation because of high-amplitude debond indications and a generally high overall noise level observed during the ultrasonic inspection as debonds. Identification of the darker areas as voids in the adhesive layer which joins the face sheet to the core material was provided by a peel test of the sample. The peel test results, shown in Figure B-2, directly correlate with both ultrasonic and radiographic results. These preliminary results established the nature of inspection conditions which could affect subsequent technique evaluation. The naturally-occurring voids

in the adhesive layer of metal-to-foam panels provided a standard debond reference for the evaluations of other test instrumentation. This reference assured the validity of the relationship between an instrument response and defect presence. Since instrument response to, or resolution of, a defect condition establishes the inspection acceptance, or rejection criteria, such a correlation must necessarily be determined to establish inspection reliability.

The sensitivity of the Transmission Radiography technique to detection of voids in the adhesive layer of metal-to-foam panels has already been documented and discussed in the Sample Preparation section of this appendix. The results of Transmission Radiography of a section of the same panel composition with water present in a series of 0.125" steps machined into the foam are presented in Figure B-9. In this radiograph, the thickest water layer is .125" thick and differentiation of this resulting image density from background density relies heavily upon the skill and training of the film reader. This situation results in limitation to the reliability of the inspection technique for use in the inspection of this panel composition. The presence of water in the individual cells of a honeycomb panel is somewhat more readily evident as shown in Figure B-10. This transmission radiograph illustrates improved signal-to-noise resulting from the increase of water layer thickness to 3/4", or a full honeycomb cell. (This radiograph, as was the radiograph shown in the previous figure, was made using KODAK INDUSTREX Instant 600 Paper and processed using the KODAK INDUSTREX Instant Processor Model P-1 paper processor. While offering a major advantage of reduction in processing time to 10 seconds, the paper method still requires the darkroom and chemicals limitation of any photographic, (i.e., light-sensitive) operation.

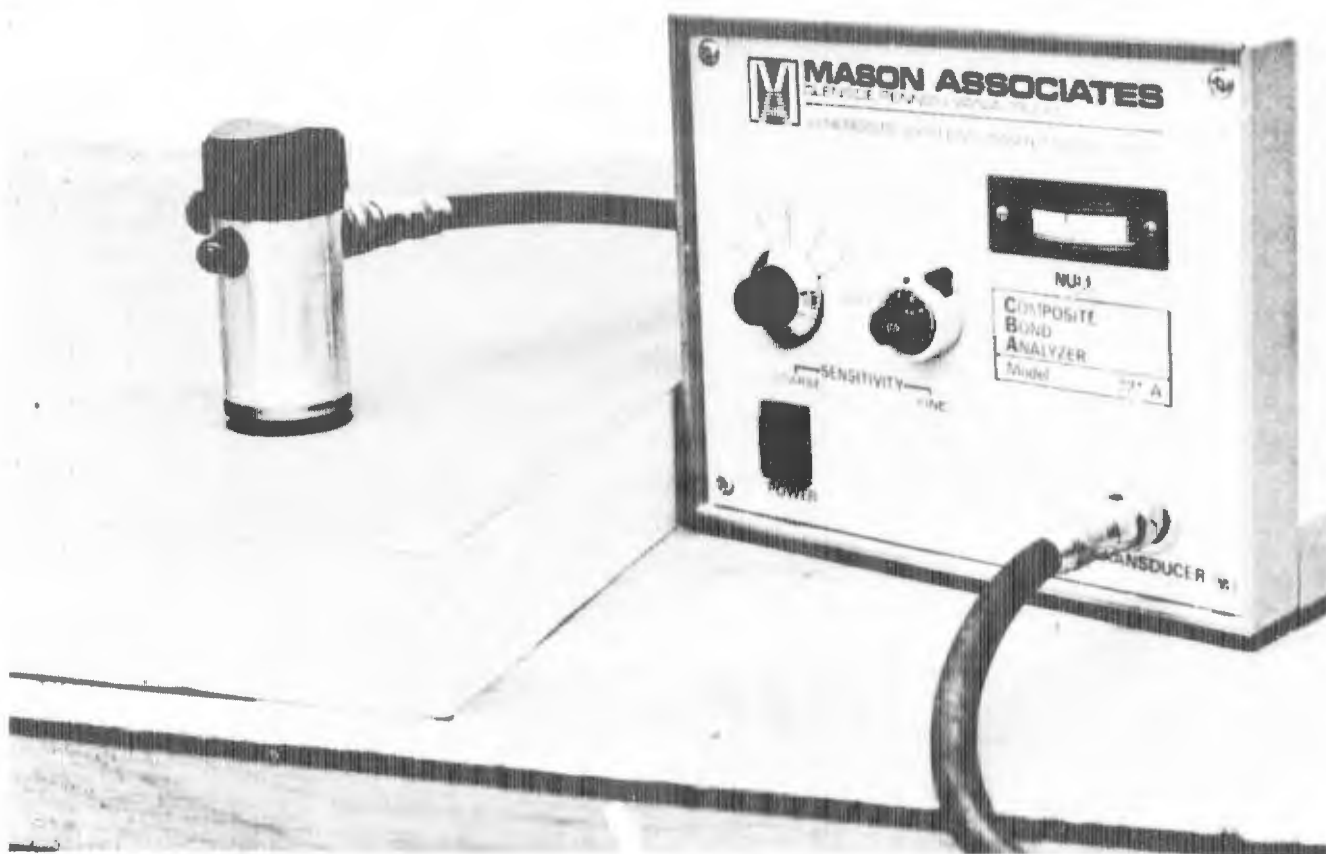
Figure B-4 VACUUM DISPLACEMENT INSPECTION INSTRUMENTATION

A well-bonded laminate is a more rigid test surface and the resulting localized displacement will be less than that which would result from a less-rigid debond area. The instrument detects debond in composite materials by application of a partial vacuum to a localized surface area of the material and measurement of any resulting displacement of that localized area. Vacuum application and displacement detection is accomplished by a single hand-held transducer. The vacuum is applied to a 3/4" diameter area and displacement is measured by a piezoelectric crystal which detects the mechanical deformation of the test surface converting it to an electrical signal for meter readout. Bond quality is determined by comparison of the meter reading with results obtained from a similar test sample of known quality.

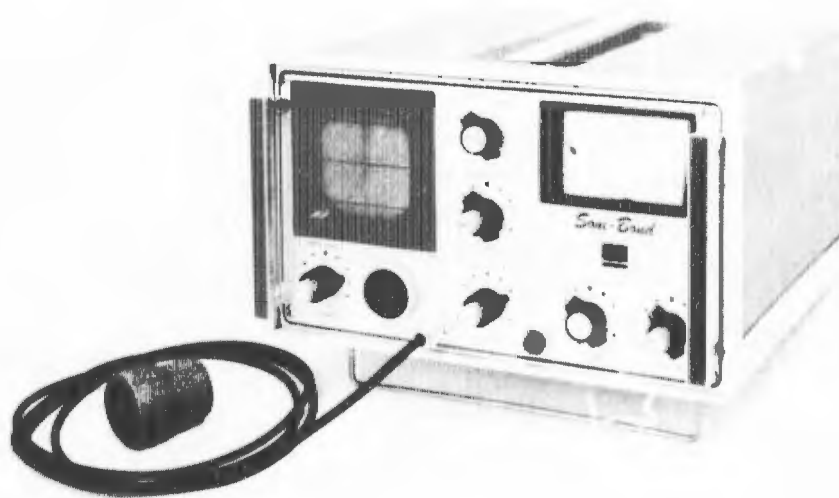
Figure B-5    RESONANCE INSPECTION INSTRUMENTATION

frequencies. This technique was evaluated for its capability to detect debond in shelter sandwich panels using the Electro-Physics Soni-Bond Model 5B-1000, illustrated in Figure B-5. This instrument generates acoustic vibrations in the range from 20kHz to 100kHz using a piezoelectric transducer and monitors the acoustic response of the material. The acoustic vibrations are introduced into the material by direct contact of the transducer to the material surface, using a liquid couplant. The test material in the area of transducer contact responds to the induced acoustic vibrations by vibrating at a resonant acoustic frequency determined by the elastic properties of the material. The amplitude of the resonant vibration is related to the structural integrity of the material in that local area. The transducer senses the resonant response which is processed by a built-in frequency spectrum analyzer. The resonant frequency is identified and displayed on a CRT presentation of an impedance bridge current vs. frequency. The bridge current is proportional to the amplitude of the resonant vibration and, since the amplitude of the resonant vibration is directly related to the elastic properties of the test material, this electrical signal is used as a measure of the structural integrity of the test material. The electrical signal is also used to operate a meter to provide quantitative numerical results or to activate an audible alarm. The instrument was evaluated for debond detection using an aluminum-to-honeycomb panel (0.050" face sheet and 1-3/4" thick resin-impregnated-paper honeycomb core) and an aluminum-to-balsawood panel (0.020" face sheet and 0.5" balsawood core). Debonds in the honeycomb panel were 1/2" to 2" in diameter and the balsawood panel contained naturally occurring debonds and two artificial debond areas created by removal of core material. These panels were scanned using the 3/4" diameter transducer provided with the instrument. (Other sizes of transducers are available from the manufacturer.) Inspection of the test panels for debond demonstrated excellent signal-to-noise relationships. CRT presentation of the bond condition in the honeycomb panel is shown in Figure B-6a. The CRT presentation of the 2" near-side debond area in the same panel is shown in Figure B-6b. Similar results were obtained from inspection of the balsa core panel. Sensitivity of the technique to far-side debond was demonstrated. However, signal-to-noise was substantially reduced.
